Fire Fighter Fatality Investigation and Prevention Program – Selected Investigation Reports

DHHS (NIOSH) Publication No. 2011-122
December 2010

Career Fire Fighter Dies When Backed Over While Spotting an Apparatus—New Jersey

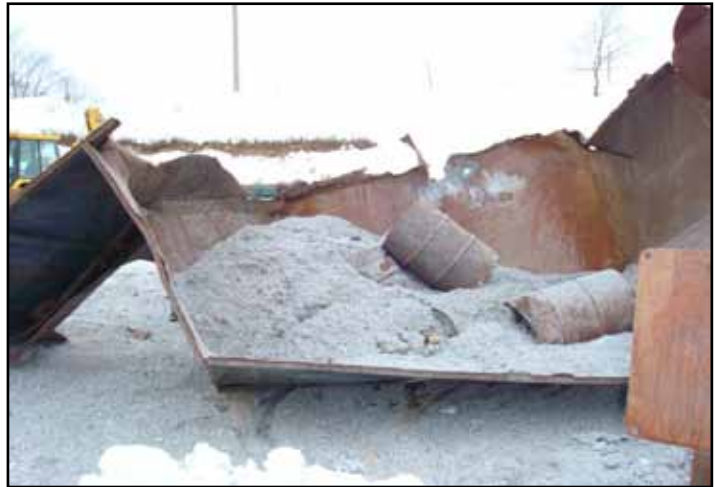
In December 2009, a 33 year old male fire fighter died and eight fire fighters, including a lieutenant and a junior fire fighter, were injured in a dumpster explosion at a foundry in Wisconsin. At 1933 hours, dispatch reported a dumpster fire at a foundry in a rural area. Eight minutes later, the initial responding crews and the incident commander (IC) arrived on scene to find a dumpster emitting approximately two-foot high bluish green flames from the open top and having a ten-inch reddish-orange glow in the middle of the dumpster's south side near the bottom. The IC used an attic ladder to

examine the contents of the dumpster: aluminum shavings, foundry floor sweepings, and a 55 gallon drum. Approximately 700 gallons of water was put on the fire with no affect. Approximately 100 gallons of foam solution, starting at 1 percent and increased to 3 percent, was then put on the fire, and again there was no noticeable effect. Just over twelve minutes on scene, the contents of the dumpster started sparking then exploded sending shrapnel and barrels into the air. The explosion killed one fire fighter and injured eight other fire fighters, all from the same volunteer department.
